# Educational Facility Evaluations of Primary Schools in Rural Honduras

Departments of Cortes and Meambar

1997

In April 1997, a team of eleven educational facility planners and architects from the United States and Canada conducted a facility evaluation of schools in rural Honduras, in the departments of Meambar and Cortes. Team members were all members of the Council of Educational Facility Planners, International and traveled to Honduras under the auspices of a Christian mission group, Heart to Honduras.

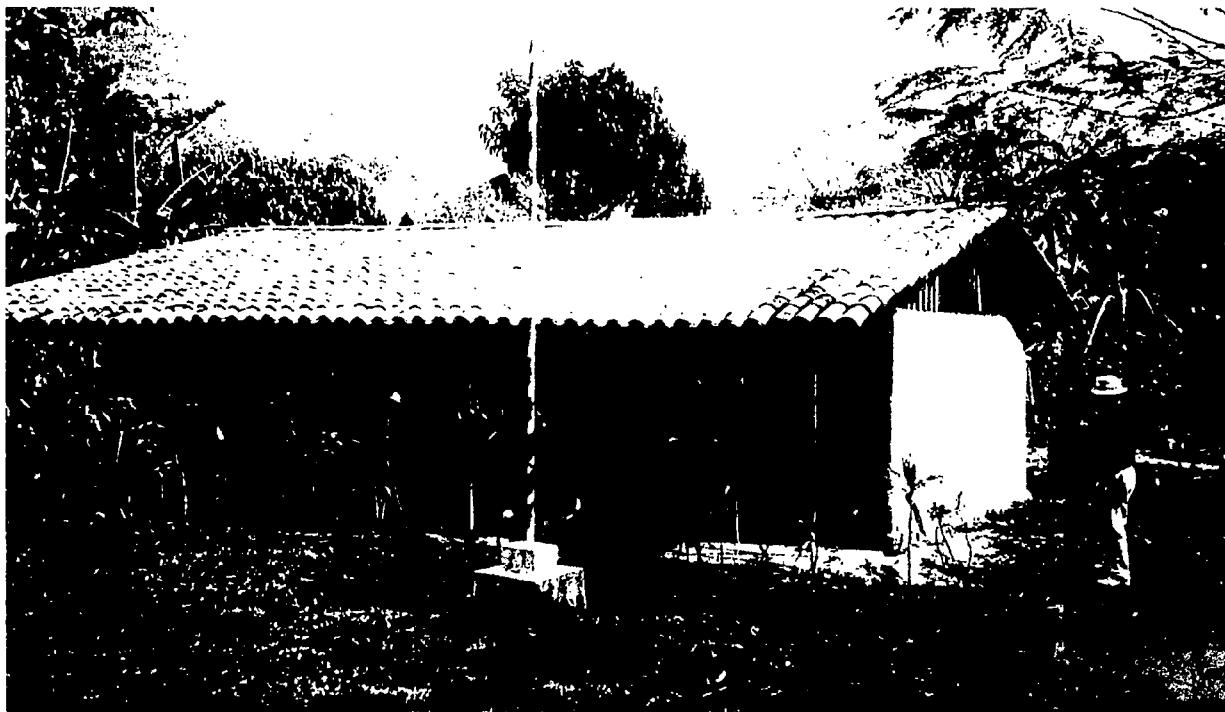
## Canchias Primary School

The site is ample. Though the school building is close to the road, the fields behind the school are level and large. There is space for an educational garden where students in all grades learn agricultural skills. The classroom space was ample and was in relatively good condition, though the dark green paint on the interior walls made the room seem darker.

CHARACTERISTIC	Condition Rate 1-5	REMARKS
<b>FACILITY - SITE:</b>		
Condition	3	
Location	4	students live nearby; site has a large flat field in which children can play
Signage	3	
<b>FACILITY - EXTERIOR:</b>		
Walls	3	
Windows/Frames	4	
Roof	4	
Doors	3	
<b>FACILITY - INTERIOR:</b>		
Floors	3	exposed concrete
Walls	5	painted
Ceilings	5	wood
Lighting	1	none
Doors	3	
Storage	3	using old classroom
Restrooms	3	3 exterior w.c.: niñas, maestro, varones
<b>FACILITY - SYSTEMS:</b>		
Electrical System	1	none available
Lighting - Natural	3	back: 6 windows; front: 2 doors, 2 windows
Lighting - Artificial	1	no artificial lighting
Plumbing System	3	One yard hydrant
<b>FACILITY - FURNITURE:</b>		
Furniture	3	painted 2-seaters
Equipment	1	none
<b>TOTAL</b>	<b>57</b>	<b>Possibility of 100</b>

<input type="checkbox"/>	Building is adequate
<input checked="" type="checkbox"/>	Building needs renovation
<input type="checkbox"/>	Building needs to be expanded
<input type="checkbox"/>	Building should be replaced

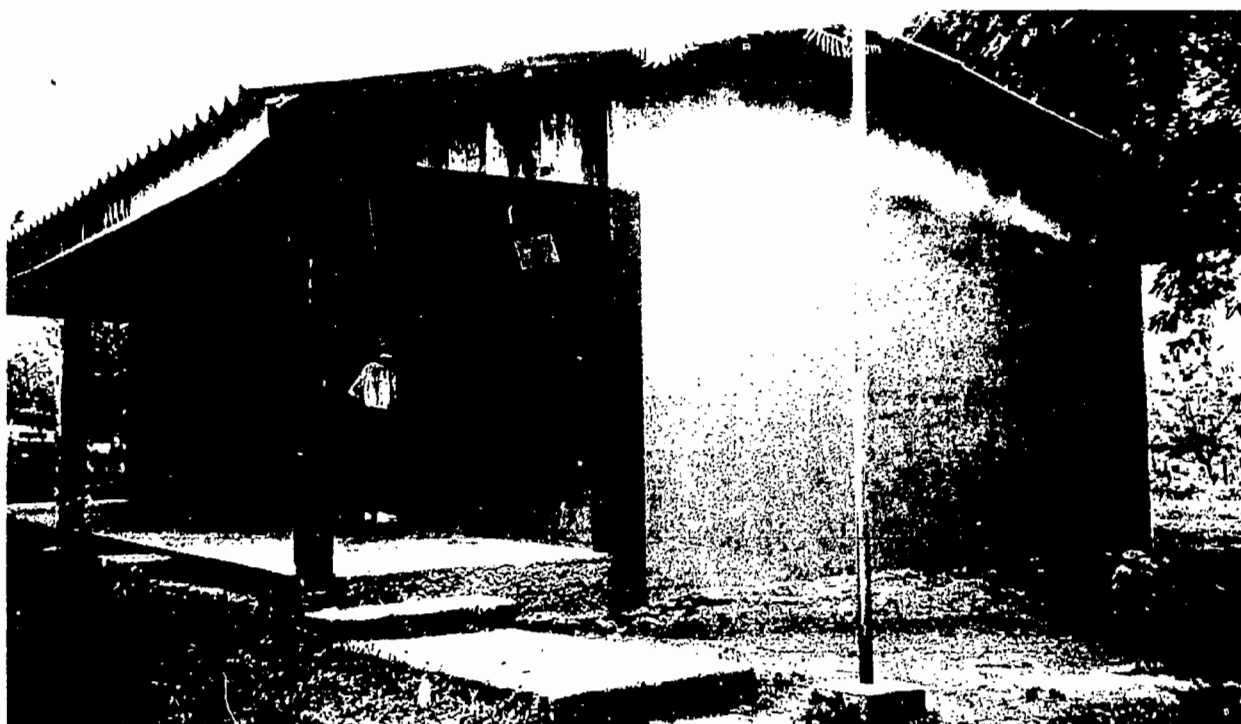
## Agua Amarilla Primary School

- There are approximately 51 students enrolled. However, when asked how many students were in each grade, student enrollment only added up to 46. We are guessing the number is wrong for second grade.
- The community is very poor. There were a number of kids not wearing clothing, while others had clothing but no shoes. In general, good hygiene was lacking. Although there is water in the village, there is also a lot of poverty.
- This building is identical to Los Globos and Montañuela. It was constructed in 1983. Like Los Globos, the old school is still there and probably used as a home for the teacher and for storage.
- Limited space, insufficient supplies and lack of equipment are the biggest challenges facing the school

CHARACTERISTIC	Condition Rate 1-5	REMARKS
FACILITY - SITE:		
Condition	2	
Location	3	
Signage	1	none
FACILITY - EXTERIOR:		
Walls	3	brick
Windows/Frames	3	open
Roof	3	metal - no gutters
Doors	3	wood
FACILITY - INTERIOR:		
Floors	3	concrete
Walls	2	plaster
Ceilings	3	open
Lighting	3	natural lighting
Doors	3	no internal doors
Storage	3	built-in bookcase
Restrooms	2	exterior
FACILITY - SYSTEMS:		
Electrical System	1	none available
Lighting - Natural	4	good
Lighting - Artificial	1	none available
Plumbing System	1	
FACILITY - FURNITURE:		
Furniture	3	26 2-student tables, appears 5 are used for storage
Equipment	1	
<b>TOTAL</b>	<b>48</b>	<b>Possibility of 100</b>

<input type="checkbox"/>	Building is adequate
<input checked="" type="checkbox"/>	Building needs renovation
<input type="checkbox"/>	Building needs to be expanded
<input type="checkbox"/>	Building should be replaced

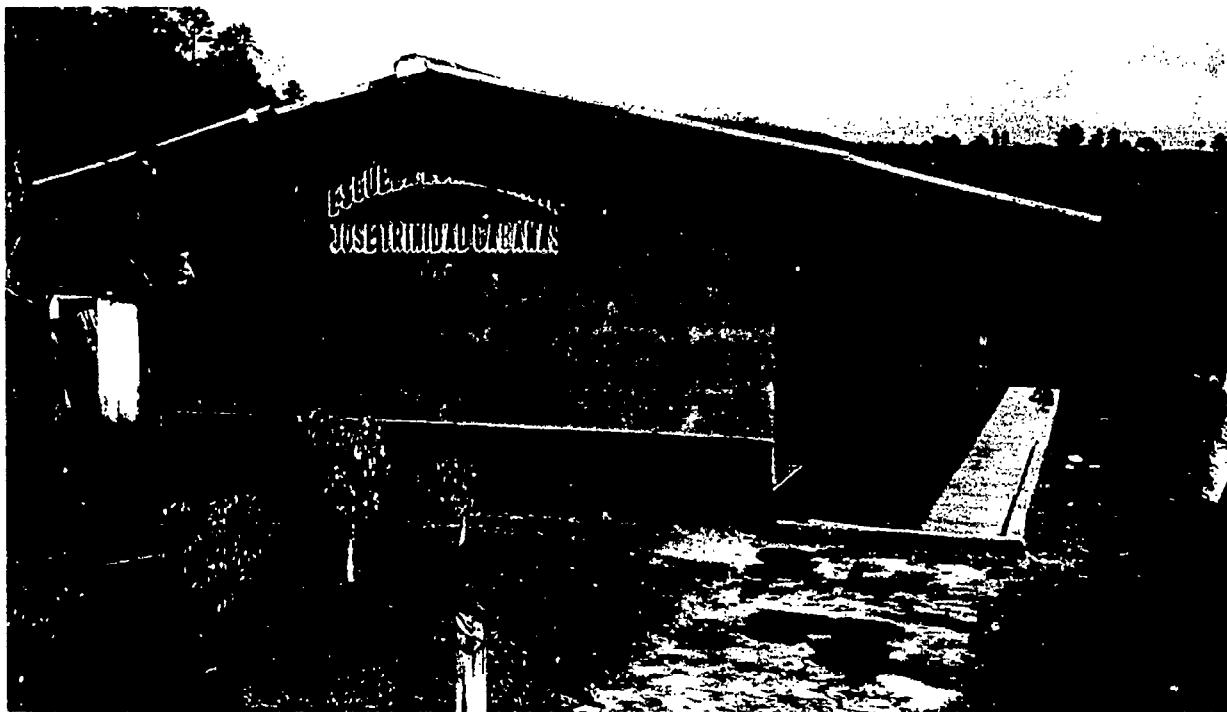
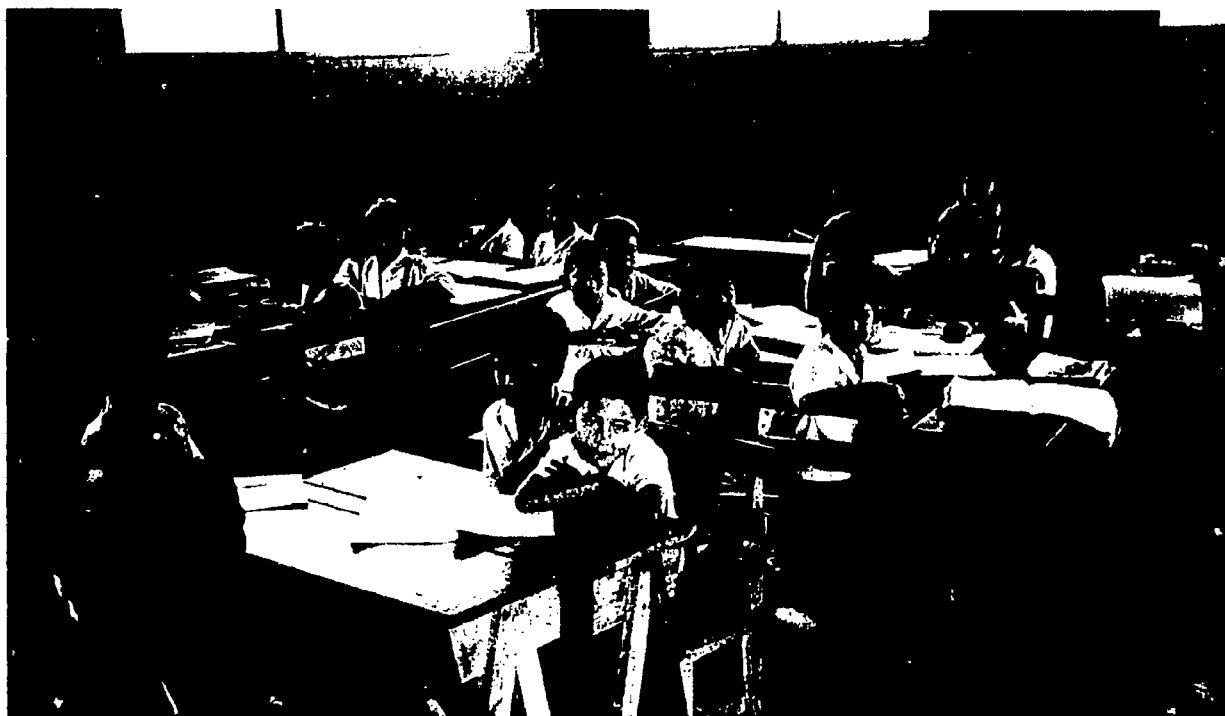
## Bartolo Primary School

CHARACTERISTIC	Condition Rate 1-5	REMARKS
<b>FACILITY - SITE:</b>		
Condition	4	separated play area
Location	3	north edge of town (4 km <sup>2</sup> area)
Signage	1	no signage
<b>FACILITY - EXTERIOR:</b>		
Walls	4	concrete frame, painted concrete block infill
Windows	3	no windows, horizontal bars and 1/4" mesh
Roof	4	cement board
Doors	2	
<b>FACILITY - INTERIOR:</b>		
Floors	3	exposed concrete
Walls	4	exposed painted concrete block
Ceilings	4	cement board
Artificial Lighting	1	natural lighting only
Doors	2	
Storage	1	small book shelf
Restrooms	1	restrooms outdoors
<b>FACILITY - SYSTEMS:</b>		
Electrical System	1	no electricity
Lighting - Natural	3	green paint makes room appear darker
Lighting - Artificial	1	
Plumbing System	2	water supply at restrooms
<b>FACILITY - FURNITURE:</b>		
Furniture	2	old wood, 2-student bench at each desk
Equipment	1	
<b>TOTAL</b>	<b>48</b>	<b>Possibility of 100</b>

Recommendations	
<i>check one</i>	
<input type="checkbox"/>	Building is adequate
<input checked="" type="checkbox"/>	Building needs improvement
<input type="checkbox"/>	Building needs to be expanded
<input type="checkbox"/>	Building should be replaced
<p><i>Comments:</i></p> <p>Even though this is a newer building, the school lacks many things such as furniture, equipment, electricity, storage, etc.</p>

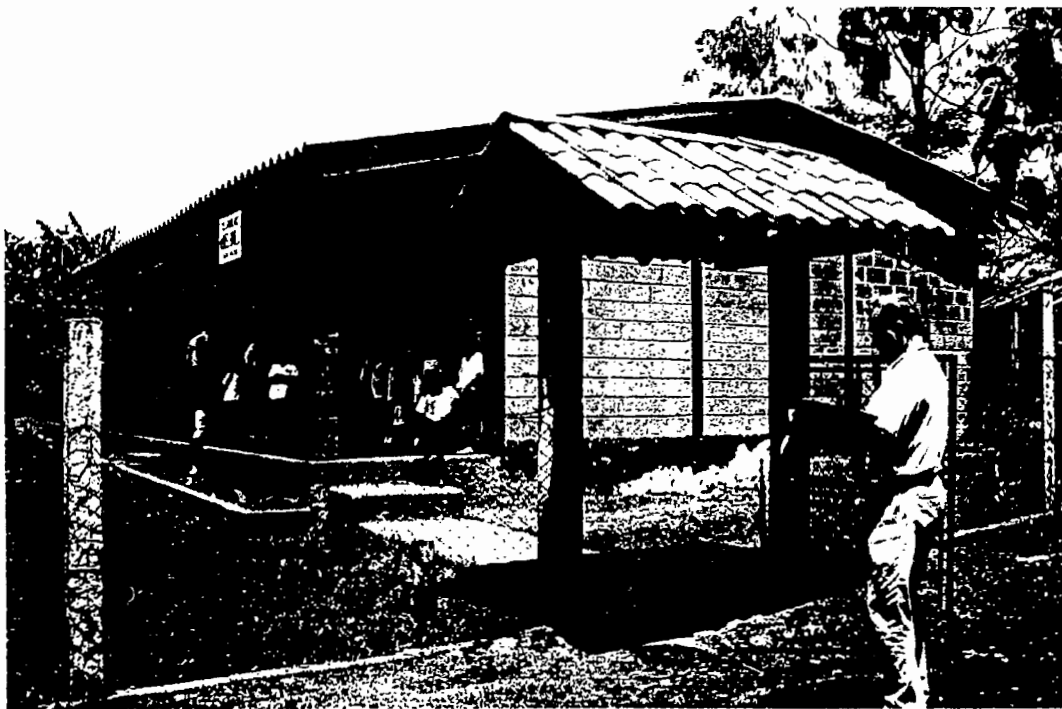
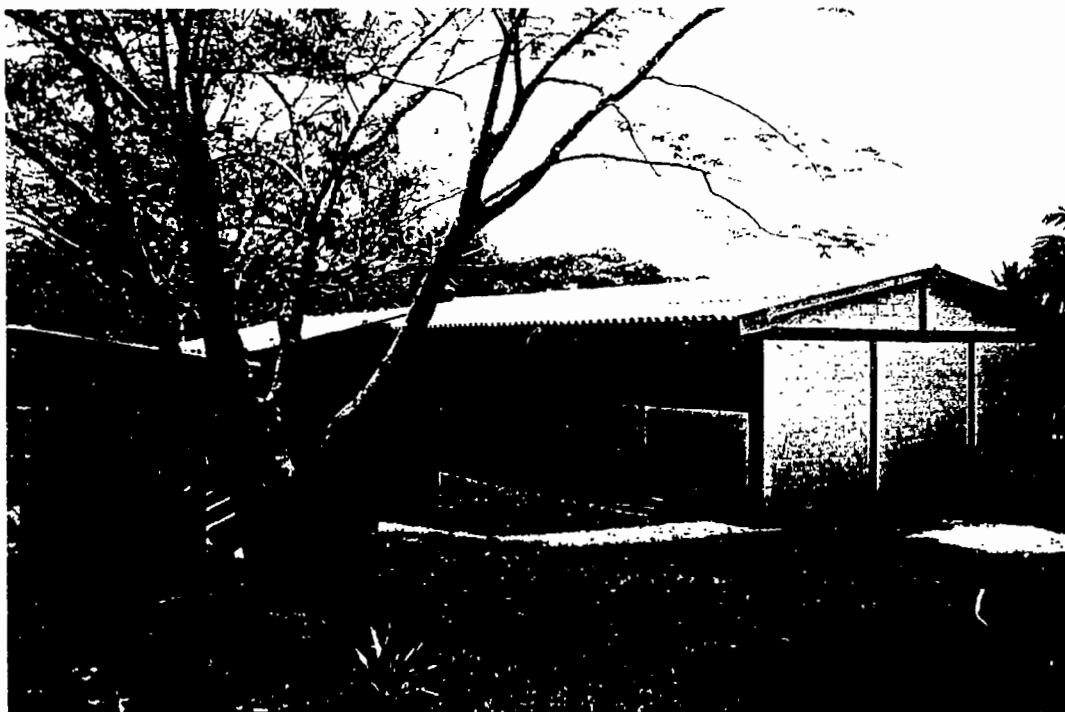
## Las Casitas Primary School

Other challenges facing the school include old and inadequate furniture and equipment, malnourished students and the open classroom building.

CHARACTERISTIC	Condition Rate 1-5	REMARKS
<b>FACILITY - SITE:</b>		
Condition	4	
Location	3	in boundary
Signage	2	painted on building
<b>FACILITY - EXTERIOR:</b>		
Walls	3	
Windows	3	wire mesh over openings, louvres on N and W; no windows
Roof	3	
Doors	4	
<b>FACILITY - INTERIOR:</b>		
Floors	3	exposed concrete
Walls	3	stucco
Ceilings	3	
Artificial Lighting	1	no artificial lighting
Doors	4	between classrooms
Storage	1	2 small cupboards, small kitchen bldg
Restrooms	4	outside
<b>FACILITY - SYSTEMS:</b>		
Electrical System	1	no electricity
Lighting - Natural	3	
Lighting - Artificial	1	
Plumbing System	2	outdoors only
<b>FACILITY - FURNITURE:</b>		
Furniture	3	in poor condition and crowded
Equipment	2	painted on walls
<b>TOTAL</b>	53	Possibility of 100

<input type="checkbox"/>	Building is adequate
<input checked="" type="checkbox"/>	Building needs renovation
<input type="checkbox"/>	Building needs to be expanded
<input type="checkbox"/>	Building should be replaced

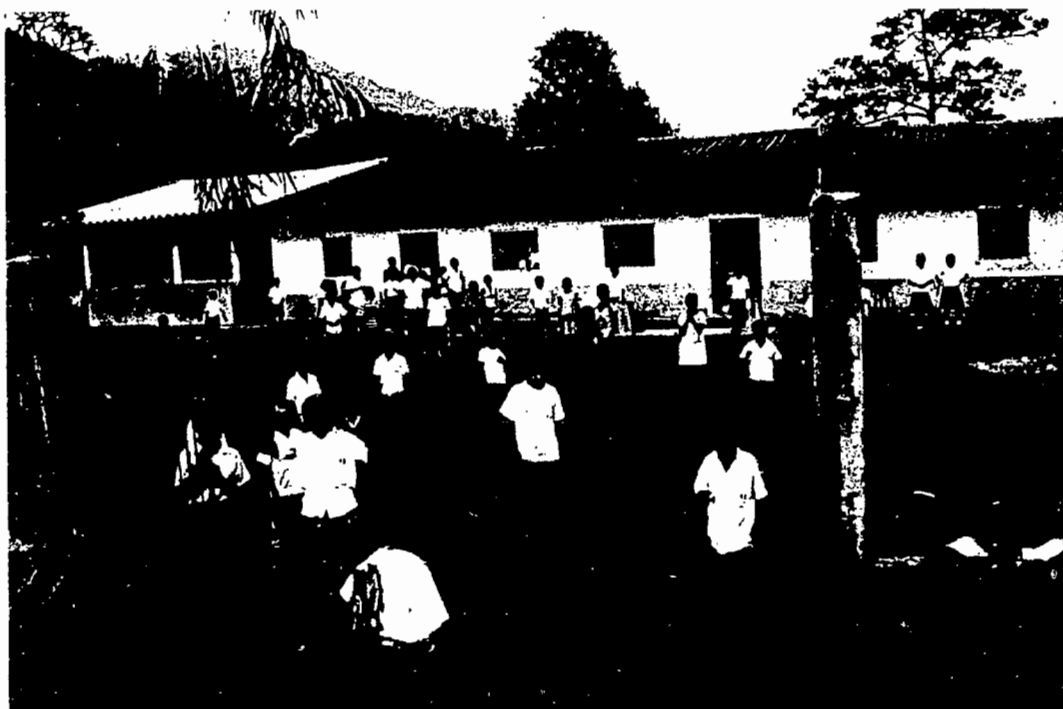
## Las Delicias Primary School

CHARACTERISTIC	Condition Rate 1-5	REMARKS
<b>FACILITY - SITE:</b>		
Condition	3	large, grassy area but severe slopes and erosion
Location	5	in center of attendance area
Signage	1	no signage
<b>FACILITY - EXTERIOR:</b>		
Walls	4	front face: concrete block 2 way, open opening above back face: concrete block to 4' below eaves, opening above
Windows/Frames	3	horizontal bars and 1" mesh; no windows
Roof	4	steel channels and transite
Doors	3	
<b>FACILITY - INTERIOR:</b>		
Floors	3	exposed concrete
Walls	3	stucco
Ceilings	1	exposed deck
Artificial Lighting	1	no artificial lighting
Doors	2	
Storage	2	small cabinet
Restrooms	3	outside
<b>FACILITY - SYSTEMS:</b>		
Electrical System	1	no electricity
Lighting - Natural	4	
Lighting - Artificial	1	no artificial lighting
Plumbing System	1	no plumbing for lack of fence (unwanted use by animals and people)
<b>FACILITY - FURNITURE:</b>		
Furniture	3	
Equipment	2	chalkboards in poor condition

The site is shared by a small Catholic Church annex. The play field consists of a large soccer field on a fairly steep grade.

Recommendations	
<i>check one</i>	
<input type="checkbox"/>	Building is adequate
<input checked="" type="checkbox"/>	Building needs renovation
<input type="checkbox"/>	Building needs to be expanded
<input type="checkbox"/>	Building should be replaced
<p><i>Comments:</i></p> <p>Even though the building is quite new and in relatively good condition, it is rated quite low as a result of a lack of electricity, lighting, and running water.</p>

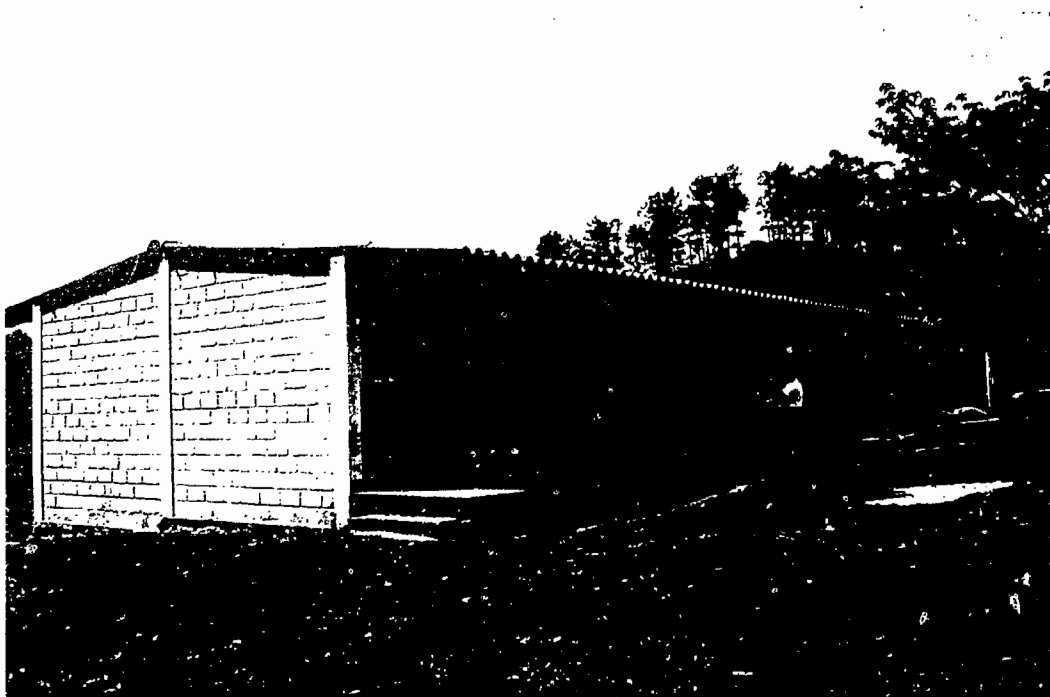
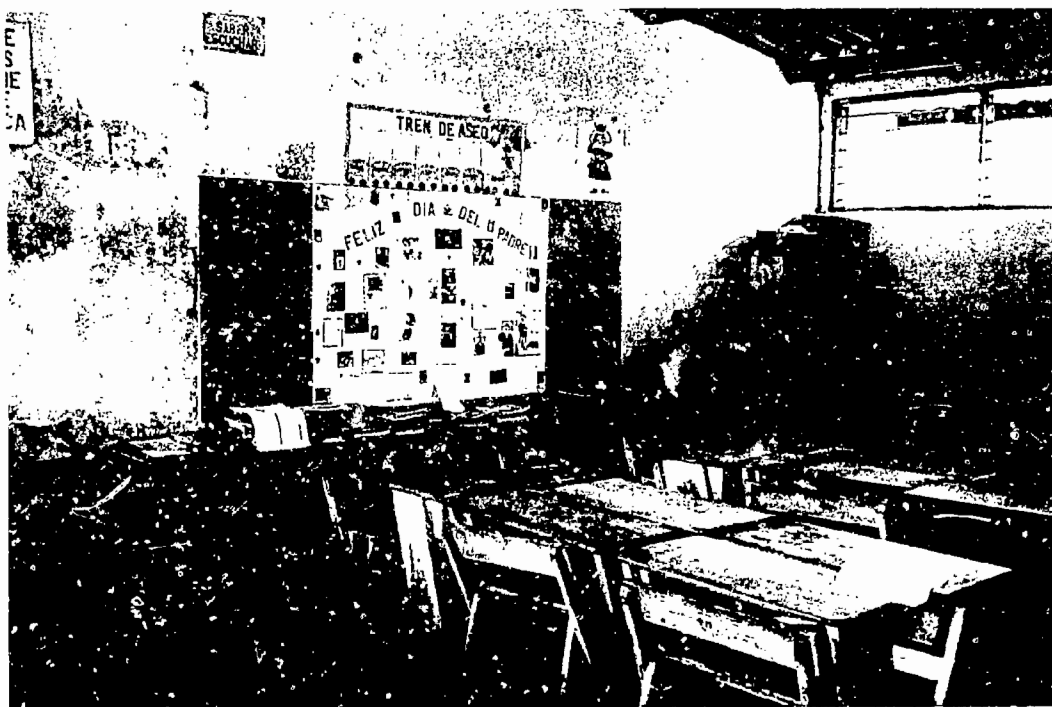
## La Victoria Primary School

CHARACTERISTIC	Condition Rate 1-5	REMARKS
<b>FACILITY - SITE:</b>		
Condition	4	limited size
Location	3	
Signage	1	
<b>FACILITY - EXTERIOR:</b>		
Walls	4	brick good
Windows/Frames	4	good - open bars not closed
Roof	4	metal
Doors	4	good
<b>FACILITY - INTERIOR:</b>		
Floors	3	exposed concrete
Walls	4	plaster
Ceilings	1	open ceiling
Lighting	1	natural lighting good, no electricity
Doors	3	1 wooden door
Storage	3	exterior building
Restrooms	2	exterior
<b>FACILITY - SYSTEMS:</b>		
Electrical System	1	no electricity
Lighting - Natural	4	good
Lighting - Artificial	1	no artificial light
Plumbing System	3	exterior but isolated
<b>FACILITY - FURNITURE:</b>		
Furniture	3	
Equipment	1	
<b>TOTAL</b>	<b>54</b>	<b>Possibility of 100</b>

Condition average but needs space. Outside learning area is great.

Recommendations	
<i>check one</i>	
<input type="checkbox"/>	Building is adequate
<input type="checkbox"/>	Building needs renovation
<input checked="" type="checkbox"/>	Building needs to be expanded
<input type="checkbox"/>	Building should be replaced
<p><i>Comments:</i></p> <p>Very limited space for the number of students served.</p> <p>Note: Older building was not included in the evaluation. It is the old school and is currently used for storage. The school has one functional classroom.</p>

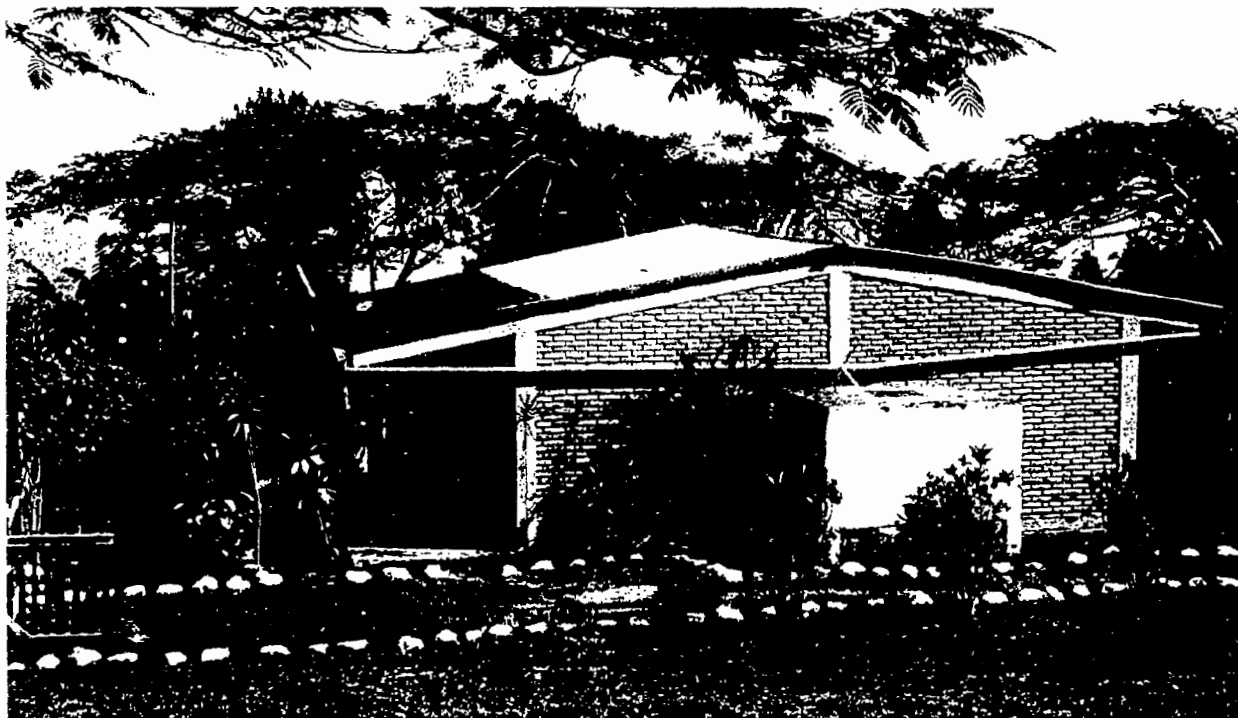
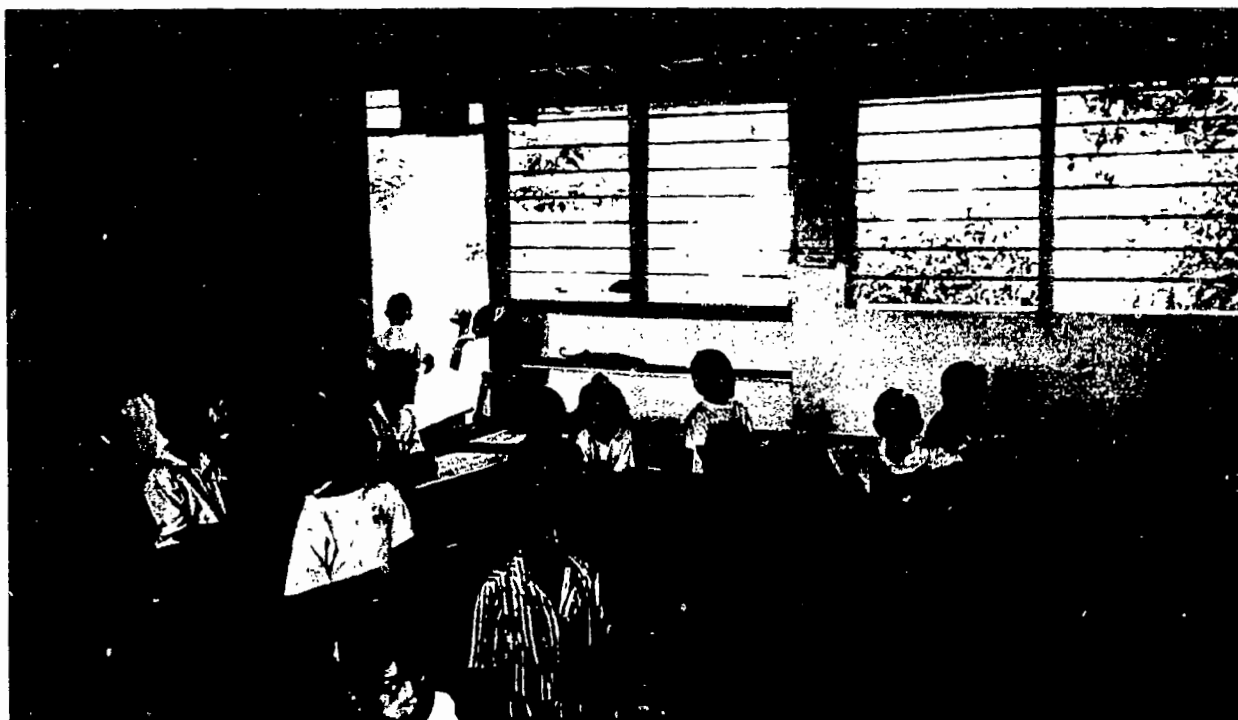
## Los Globos Primary School

CHARACTERISTIC	Condition Rate 1-5	REMARKS
<b>FACILITY - SITE:</b>		
Condition	3	
Location	3	
Signage	1	no signage
<b>FACILITY - EXTERIOR:</b>		
Walls	4	painted front
Windows/Frames	3	
Roof	3	
Doors	3	
<b>FACILITY - INTERIOR:</b>		
Floors	3	exposed concrete
Walls	2	need painting
Ceilings	1	open ceiling
Lighting	1	natural lighting only
Doors	2	poor condition
Storage	4	extra building w/ doors and bookshelves
Restrooms	3	outdoor
<b>FACILITY - SYSTEMS:</b>		
Electrical System	1	no electricity
Lighting - Natural	4	good
Lighting - Artificial	1	no artificial lighting
Plumbing System	1	
<b>FACILITY - FURNITURE:</b>		
Furniture	3	painted
Equipment	2	globe, scale, flip chart
<b>TOTAL</b>	<b>48</b>	Possibility of 100

The building needs some interior painting and additional space. There are currently 232-student tables and 4 in storage. In the front of the room, there is an 8' section of writing board. There is also a table with supplies.

Recommendations	
<i>check one</i>	
<input type="checkbox"/>	Building is adequate
<input checked="" type="checkbox"/>	Building needs renovation
<input checked="" type="checkbox"/>	Building needs to be expanded
<input type="checkbox"/>	Building should be replaced
<p><i>Comments:</i></p> <p>Even though this one room classroom was built in the early 1980s, it lacks adequate space and support facilities. The entire building consists of one 485 s.f. room.</p>

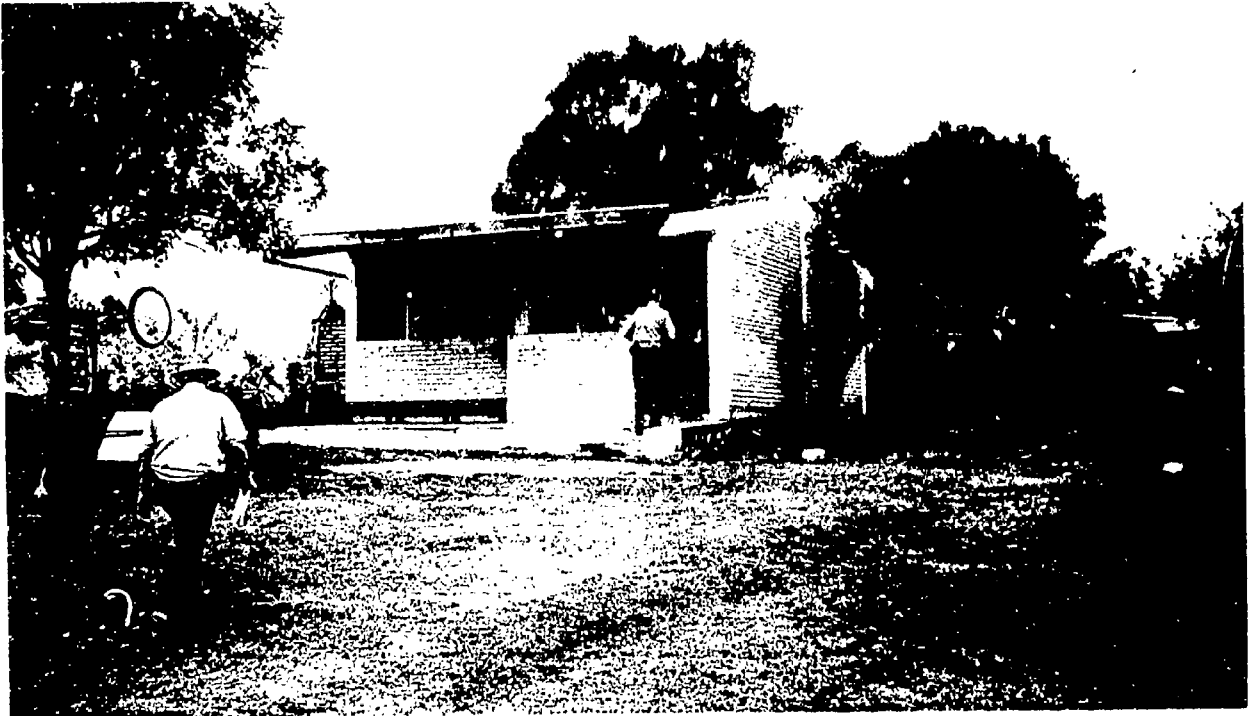
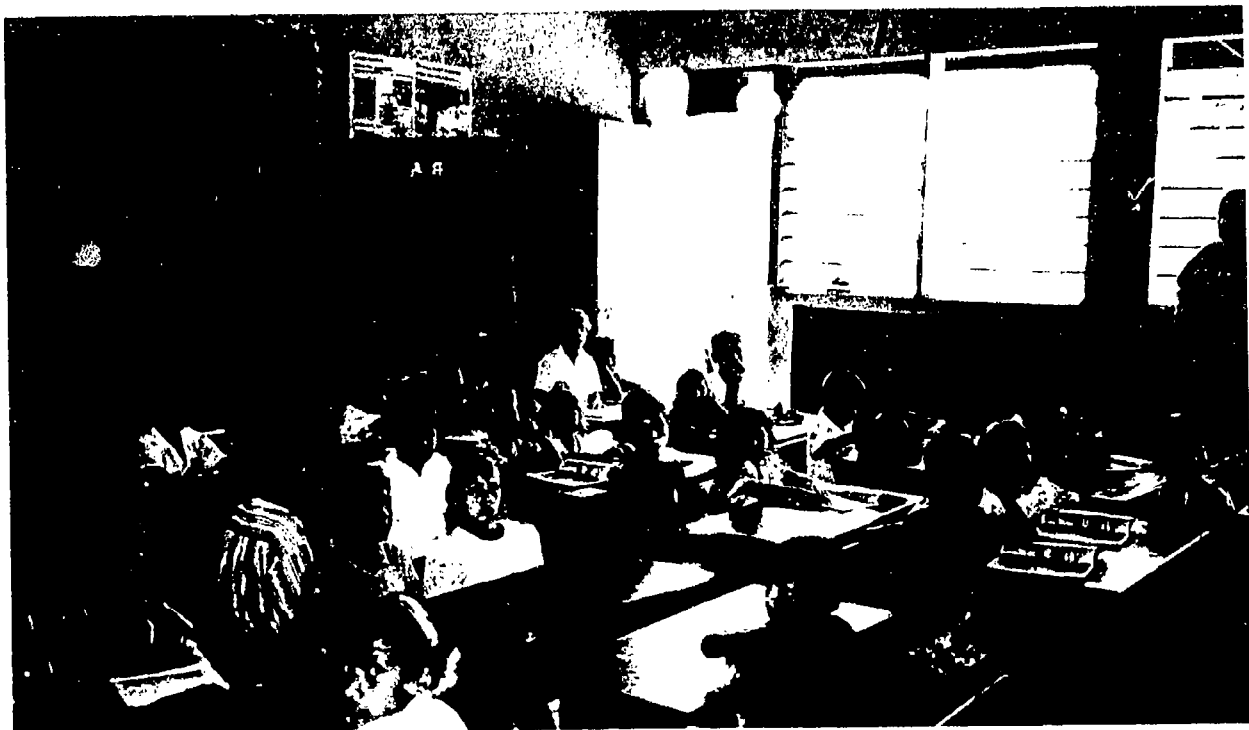
## Montañuela Primary School

CHARACTERISTIC	Condition Rate 1-5	REMARKS
<b>FACILITY - SITE:</b>		
Condition	2	very small
Location	2	very close to road
Signage	1	
<b>FACILITY - EXTERIOR:</b>		
Walls	A: 2; B: 3	A: vertical wood siding; B: stucco
Windows/Frames	A: 2; B: 3	A: Two 2x2 wooden framed windows B: permanent opening w/ mesh on N mesh on open block on S
Roof	3	A: tile; B: tin
Doors	A: 2; B: 3	A: unsecured concrete blocks as steps B: pile of loose rocks at top of stairs leading to class room
<b>FACILITY - INTERIOR:</b>		
Floors	3	A, B: exposed concrete
Walls	A: 2; B: 3	A: painted wood; B: white plaster
Ceilings	1	open
Lighting	A: 1; B: 3	A: one incandescent, 1 tube florescent B: 2 florescent, good natural light
Doors	3	A: 2 doors; B: 1door
Storage	2	A: using beams to store some maintenance items, B: none
Restrooms	3	2 flush toilets
<b>FACILITY - SYSTEMS:</b>		
Electrical System	4	A: electric panel, 2 duplex outlets
Lighting - Natural	A: 1; B: 4	A: 2 small windows, 2 doors B: large open space at top of N, S walls

Access to Building B is down some concrete stairs, at the top of which is a pile of rocks which seem to have been placed there intentionally. Access is hindered by the pile.

Recommendations	
<i>check one</i>	
<input type="checkbox"/>	Building is adequate
<input type="checkbox"/>	Building needs renovation
<input checked="" type="checkbox"/>	Building needs to be expanded
<input checked="" type="checkbox"/>	Building should be replaced
<p><i>Comments:</i></p> <p>Building A should be replaced. The entire school should be expanded to eliminate the split shift and to accommodate students in grades 4-6.</p>

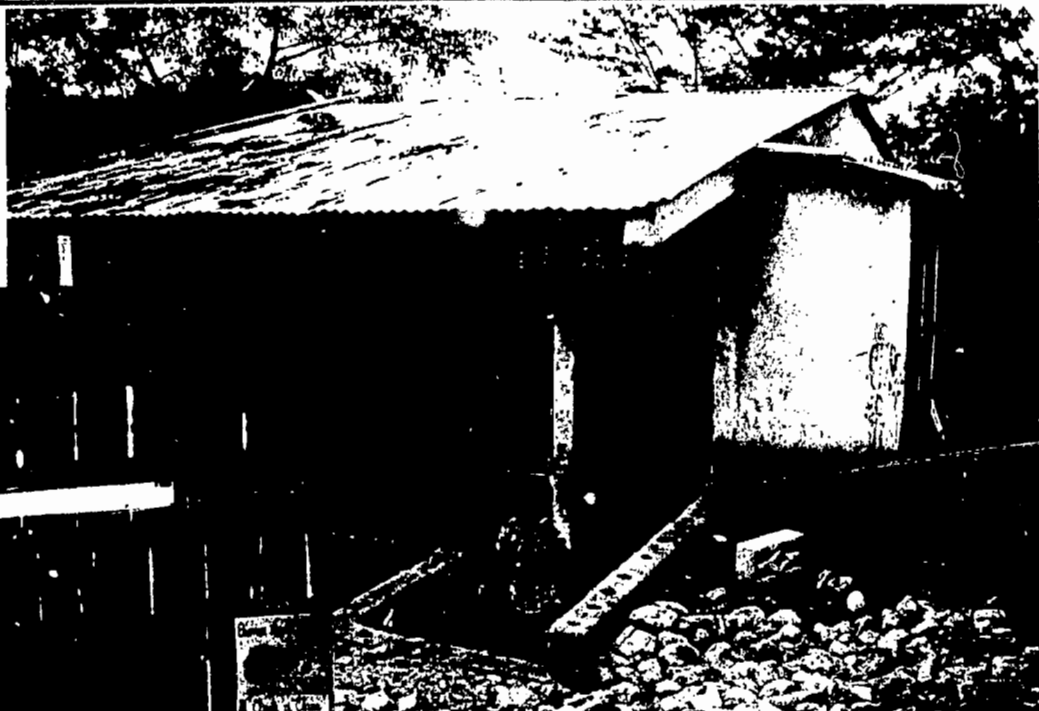
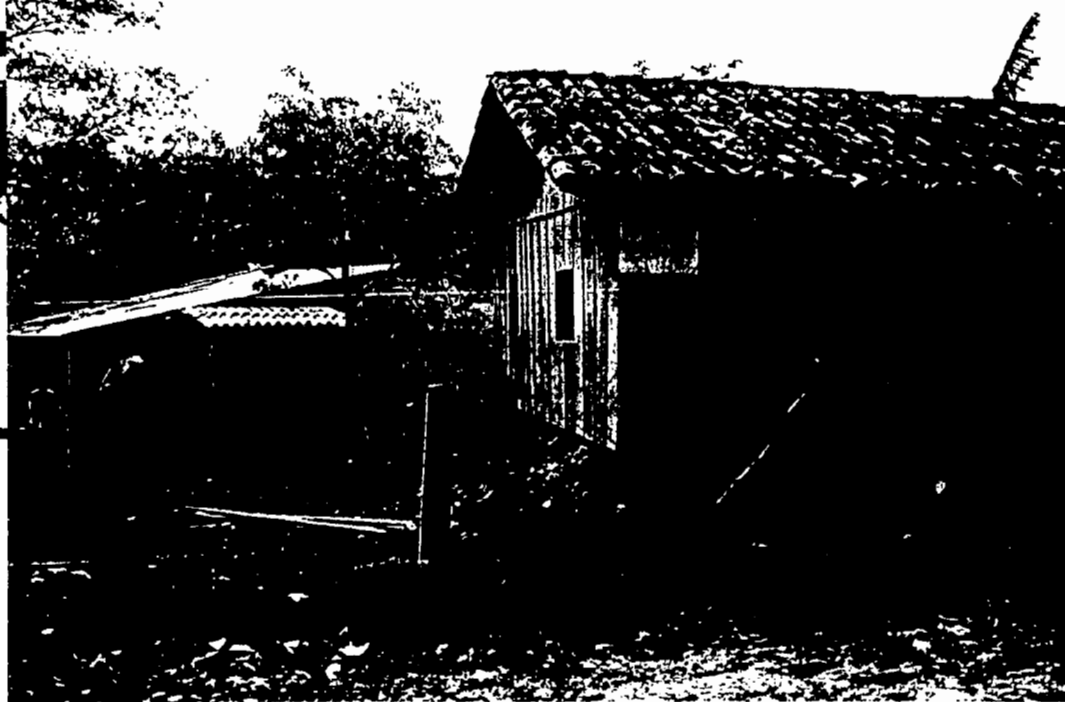
# San Isidro Primary Christian School

CHARACTERISTIC	Condition Rate 1-5	REMARKS
FACILITY - SITE:		
Condition	4	paved basketball court
Location	4	centrally located in attendance area
Signage	4	
FACILITY - EXTERIOR:		
Walls	3	
Windows/Frames	3	1/4" mesh, exposed frames and horizontal bars
Roof	2	
Doors	3	
FACILITY - INTERIOR:		
Floors	2	exposed concrete floor chipped and dusting
Walls	3	stucco (dark green)
Ceilings	2	
Lighting	2	single, incandescent socket (no lamp)
Doors	3	
Storage	1	
Restrooms	4	
FACILITY - SYSTEMS:		
Electrical System	2	limited
Lighting - Natural	3	
Lighting - Artificial	2	
Plumbing System	4	
FACILITY - FURNITURE:		
Furniture	3	
Equipment	1	no cabinets in some classrooms
<b>TOTAL</b>	<b>55</b>	<b>Possibility of 100</b>

- ☒ Roof has leaking problems in places that are beginning to cause interior and exterior damage.
- ☐ Roof has been recently repaired.
- ☐ Roof is in good condition.

Recommendations	
<i>check one</i>	
<input type="checkbox"/>	Building is adequate
<input checked="" type="checkbox"/>	Building needs renovation
<input type="checkbox"/>	Building needs to be expanded
<input type="checkbox"/>	Building should be replaced
<p><i>Comments:</i></p> <p>Building is adequate. Since this school was built in various stages, it is in various conditions. Even though there is electricity, there are very few lights or outlets and no audiovisual equipment.</p>
